Manhole Inspection Summary

Manhole # S11KK_011MH

Insp Date: **7/10/08 10:06 AM**

Location Address: **REAR OF 1910 LONGWOOD ST** Cross Street: **WALBROOK AVE**

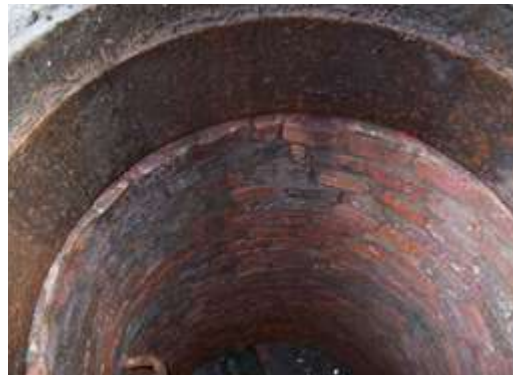
Defect 2

Corbel Material: **Brick** ☐ Parged Type: **Concentric/Eccentric**

Condition: ☐ Sound ☒ **Cracked** ☐ Root Intrusion ☐ Loose Brick ☐ Deteriorated

CRACKED CORBEL

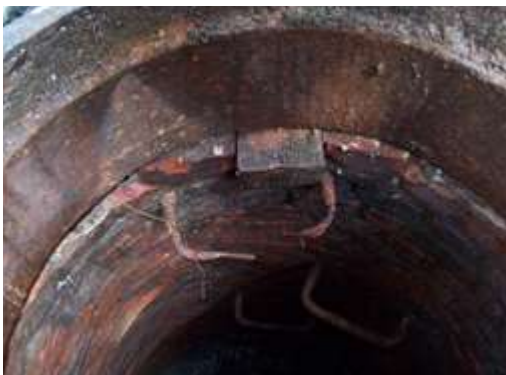
Defect 1

Chimney / Frame Adjustment ☒ Exists Material: **Brick** ☐ Parged Height: **2** (in.)

Condition: ☐ Sound ☒ **Cracked** ☐ Root Intrusion ☒ **Loose Brick** ☐ Deteriorated

Steps Count: **4** Missing: **1** ☒ **Corroded**

LOOSE BRICKS CHIMNEY/FRAME
ADJUSTMENT. CORRODED STEP.

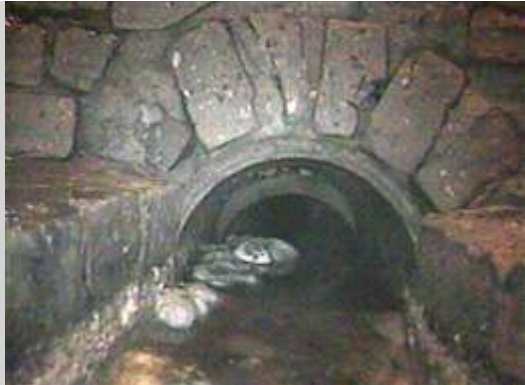
12 O'Clock Outflow

8 in. Circular Gravity Sewer
Pipe Out @ 12 O'Clock

Invert Depth: **8.90** (ft.) Flow Characteristics: **Slow**

Deposits: ☐ None ☐ Mud ☒ Sludge ☒ Debris ☐ Grease

Silt Depth: **1.5** (in.) Deposits Extent: **Light**

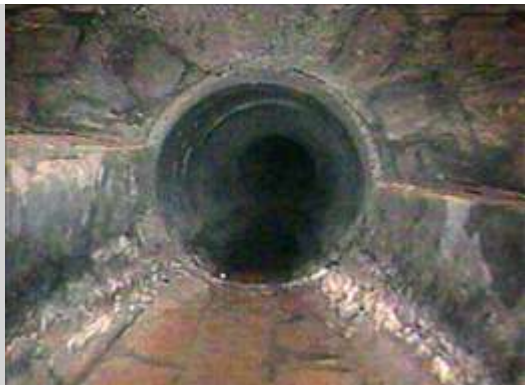
6 O'Clock Inflow

8 in. Circular Gravity Sewer
Pipe In @ 6 O'Clock

Invert Depth: **8.88** (ft.) Flow Characteristics: **Slow**
